Home Inspection Report

123 Example Ln

Inspected on Sat, Feb 23 2019 at 8:15 PM

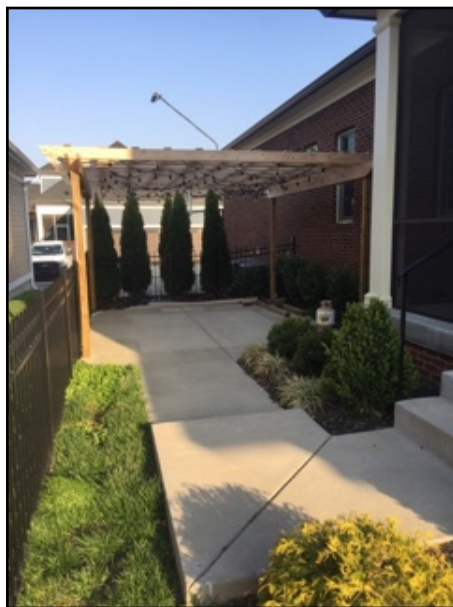
Figure 2-1

Comment 2:
Patio and pergola are in acceptable condition. Keep pergola maintained.

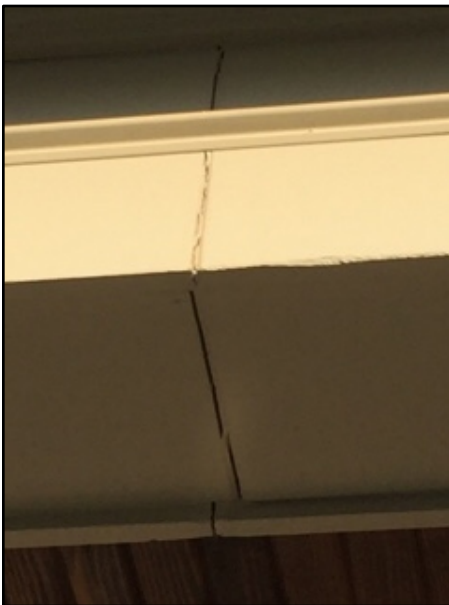
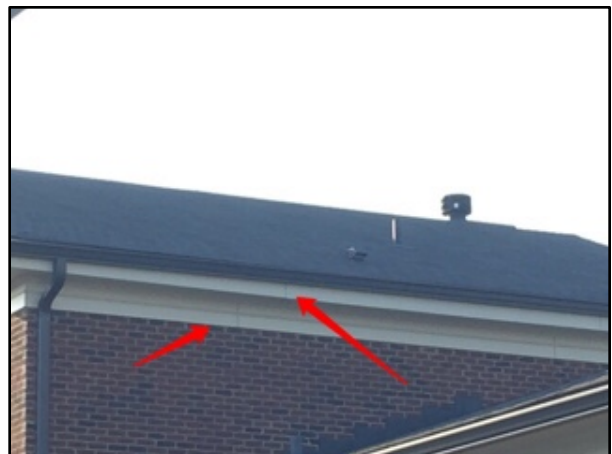
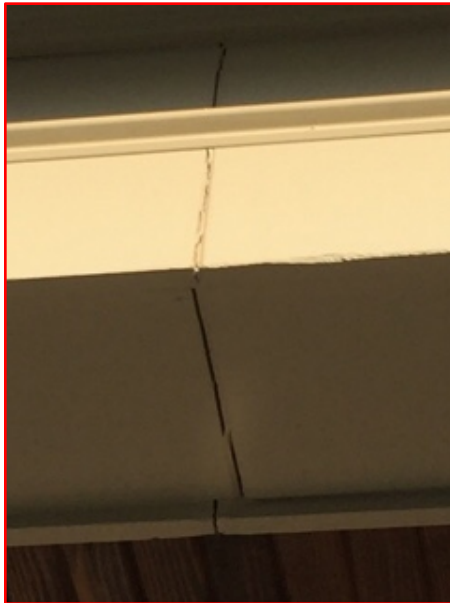
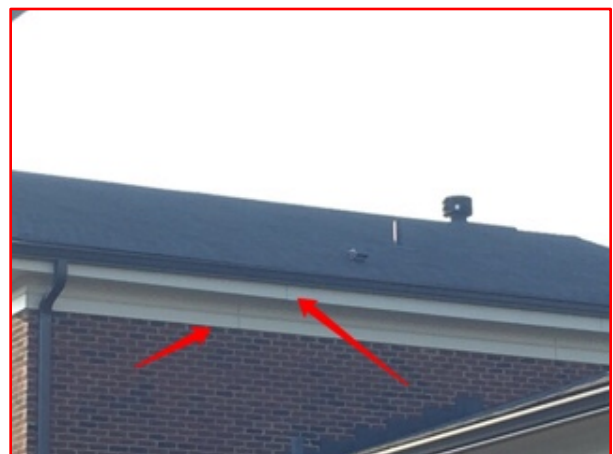
Figure 3-1

Several areas of gaps in exterior trim. Have caulked and painted to protect from weather.

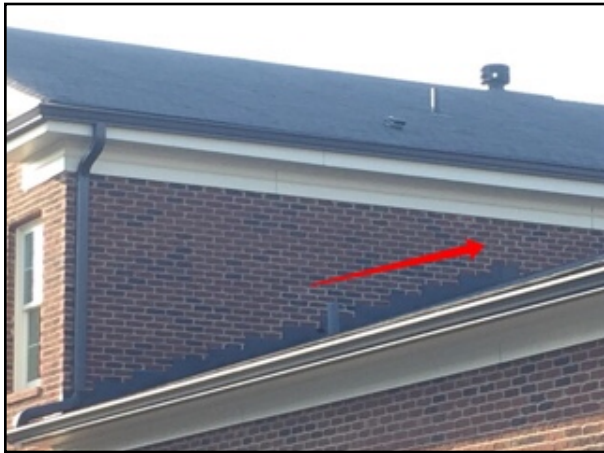
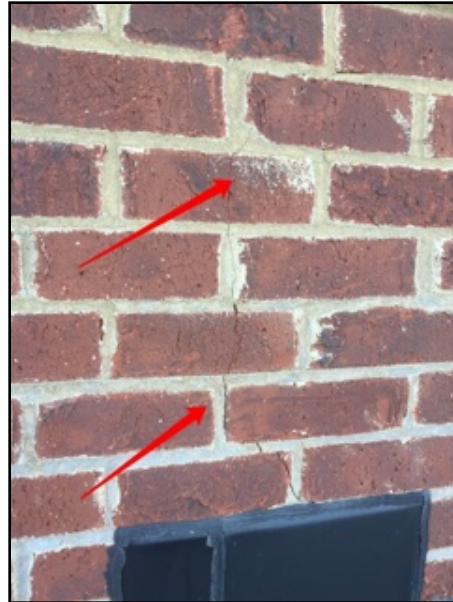
Figure 4-1

i Comment 4:
There are hairline brick cracks above rear roof. This is not a structural issue.
Monitor and repair by tuck pointing if needed.

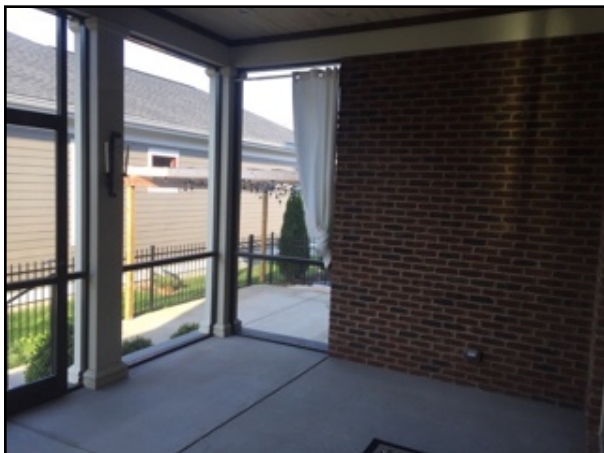
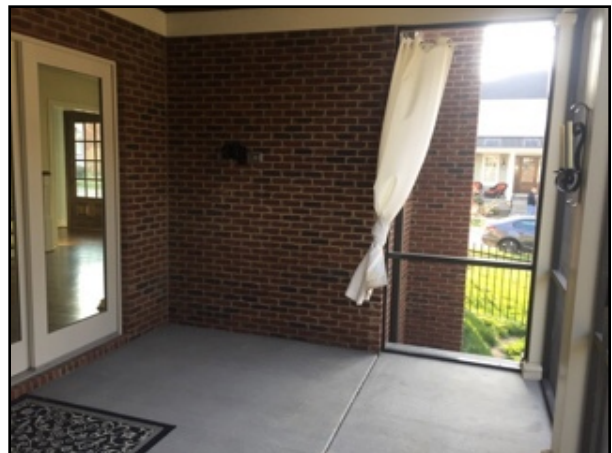
Figure 5-1

i Comment 5:
Screen porch is in acceptable condition. Ok.

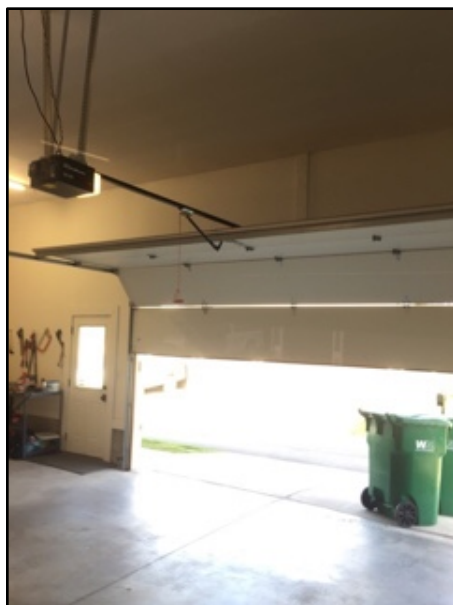
Figure 6-1

Comment 6:
Vehicle door and opener operates as expected.

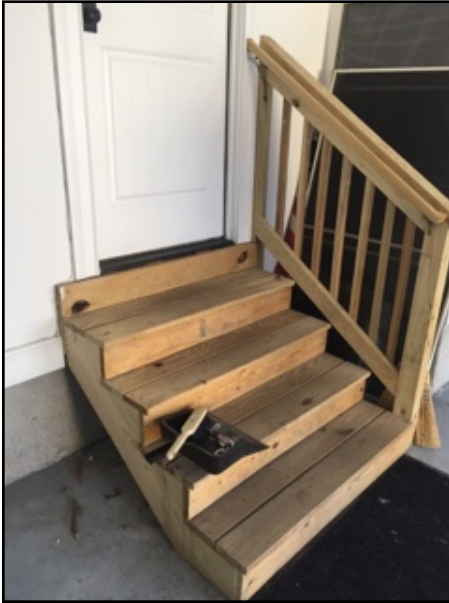
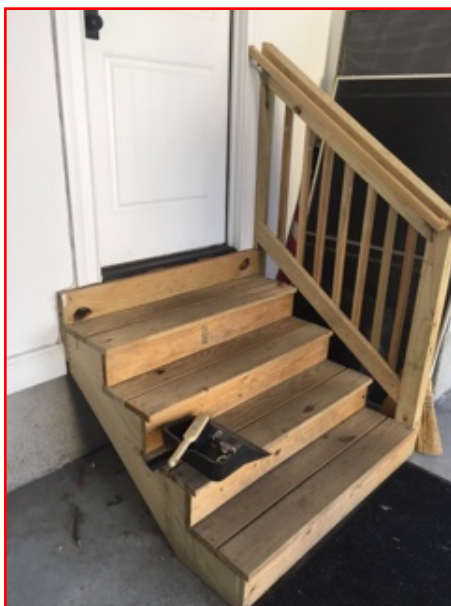
Figure 7-1

Steps in garage are missing handrail & guardrail. Install for safety.

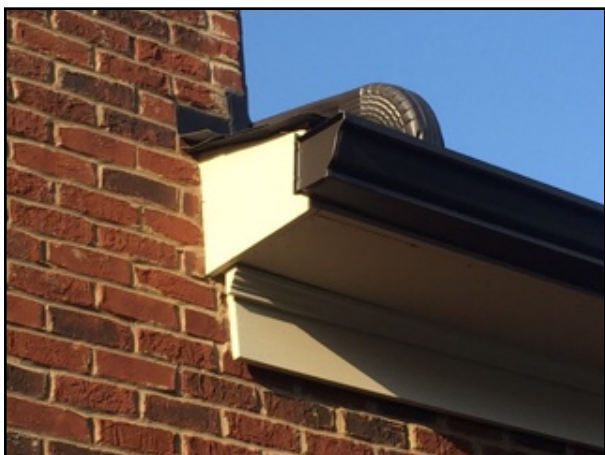
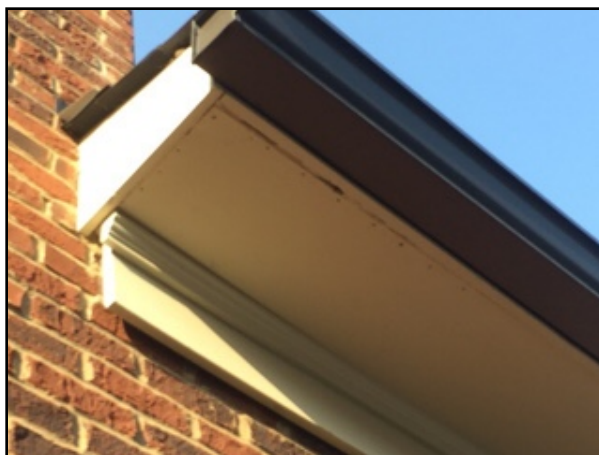
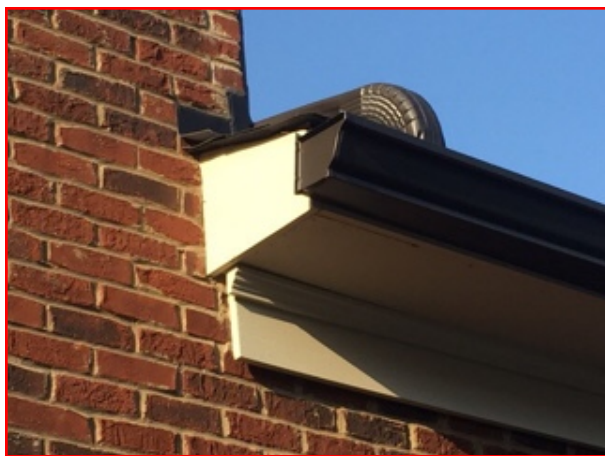
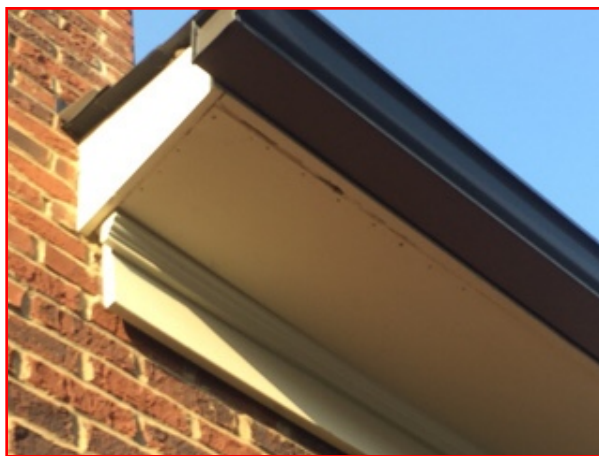
Figure 8-1

Prior repairs to rear right soffit. Have owner explain when and why repairs were made. Monitor.

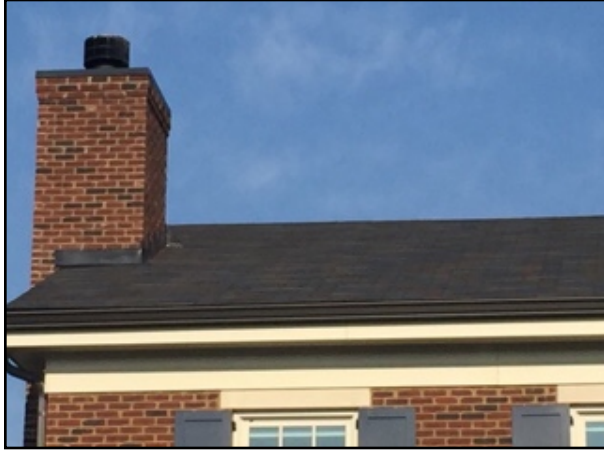
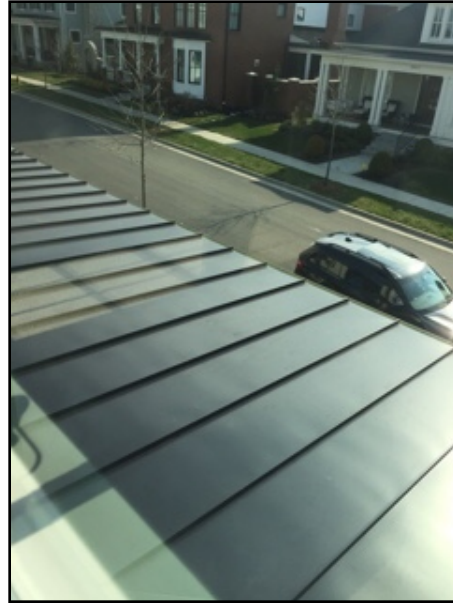
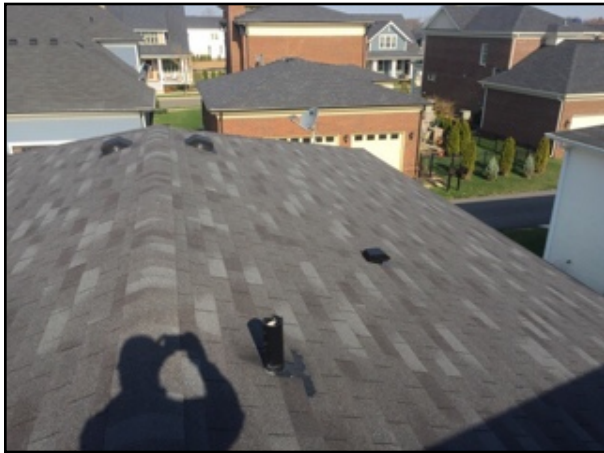
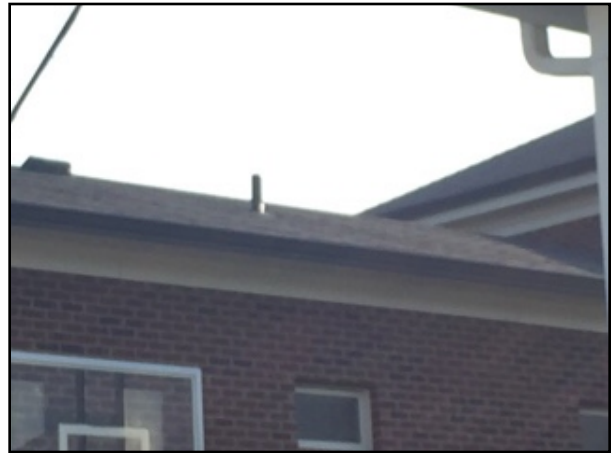
Figure 9-1

Visible roofing and gutters are in acceptable condition unless otherwise noted.

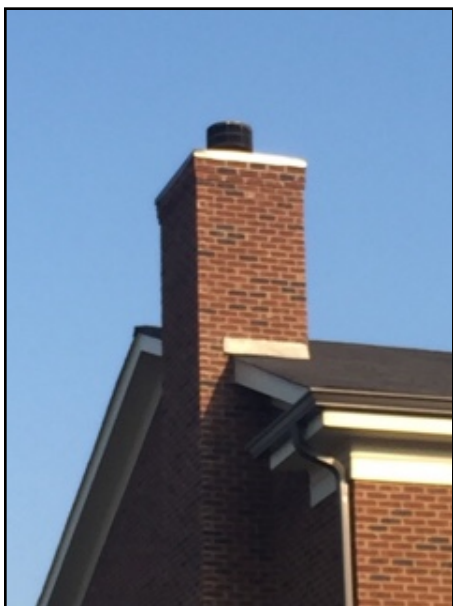
Figure 10-1

Comment 10:
Chimney is in acceptable condition. Ok.

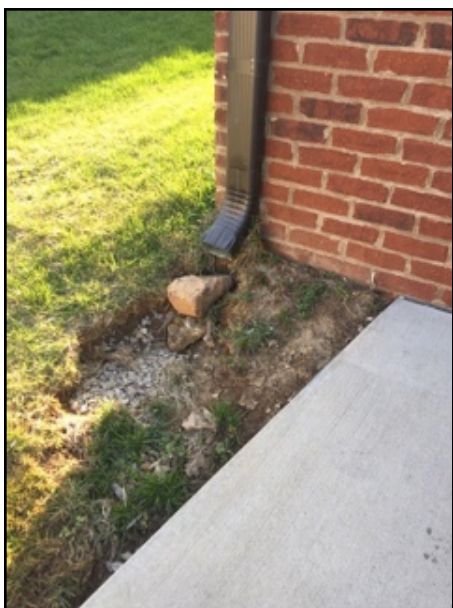
Figure 11-1

Comment 11:
Rear garage downspout washing out soil. Install splash block and monitor.

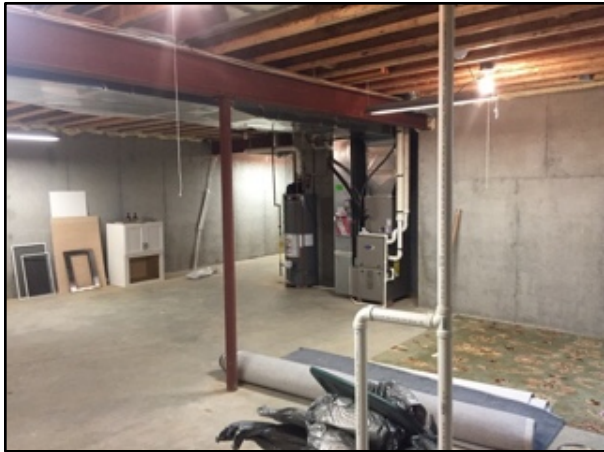
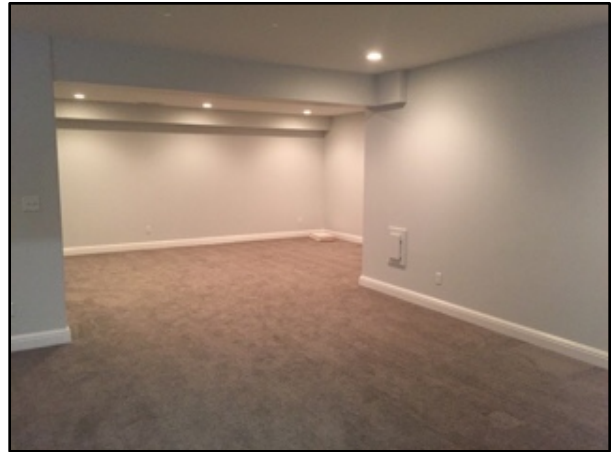
Figure 12-1

Majority of basement is finished with paneling, drywall and/or carpet. Very little of foundation is visible to inspect.

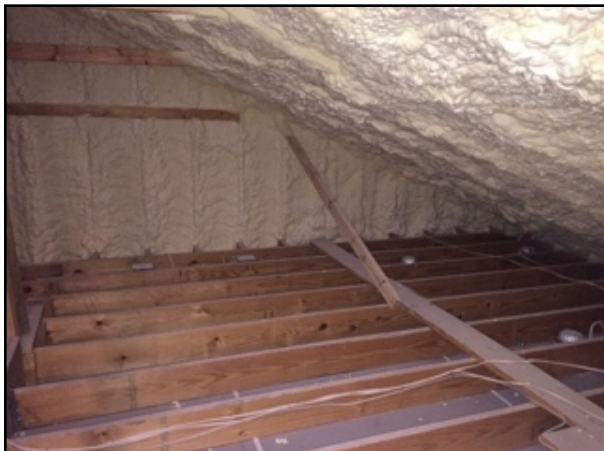
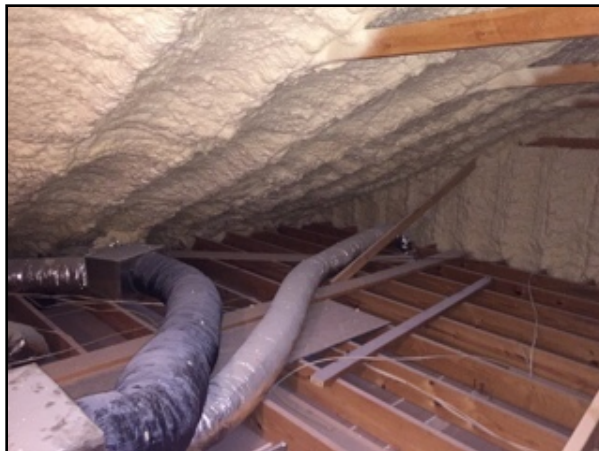
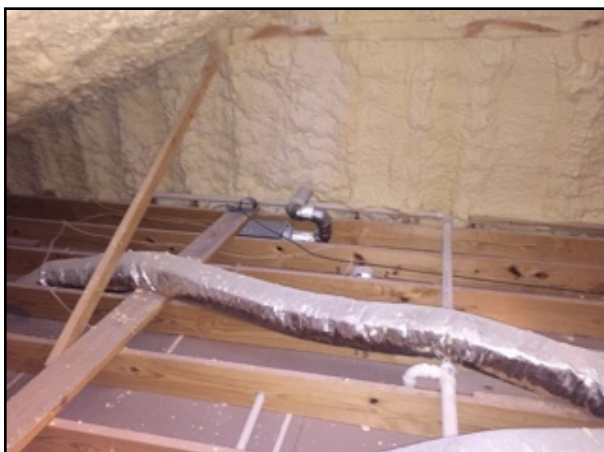
Figure 13-1

View inside attic. Ok. Most of roof structure was covered with insulation and was not visible.

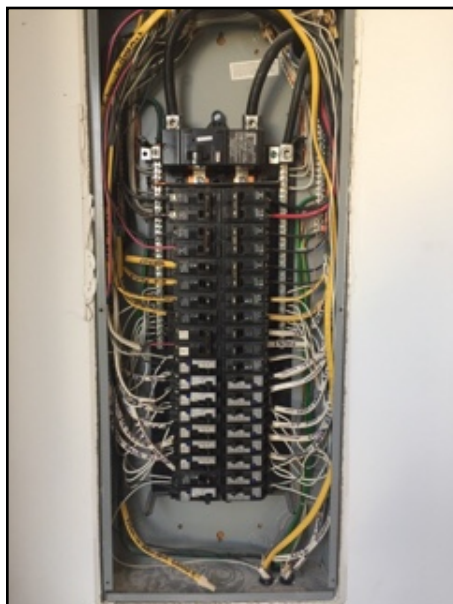
Figure 17-1

Comment 17:
Inside electrical panel. Ok

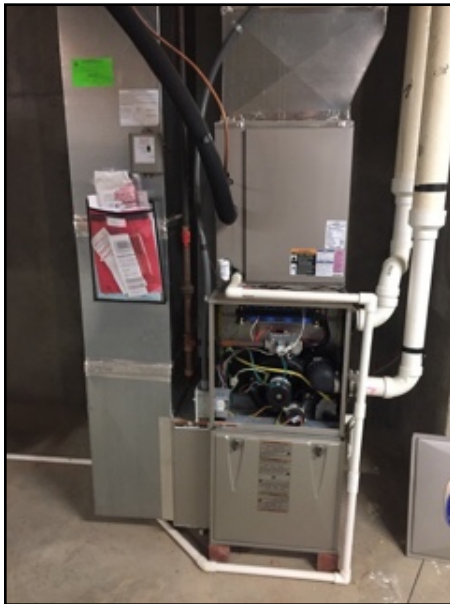
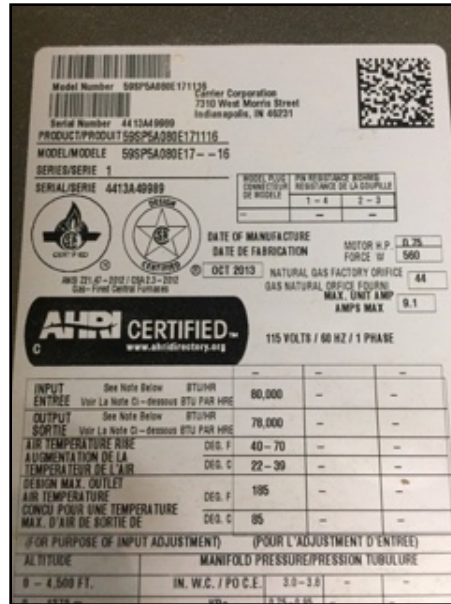
Figure 18-1

Comment 18:
Furnace and data plate. Operates as expected.

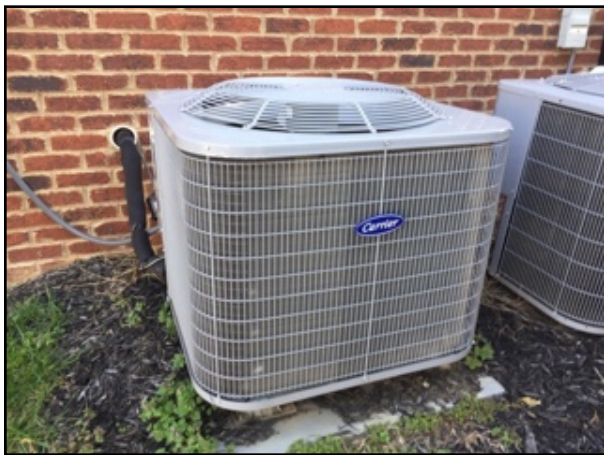
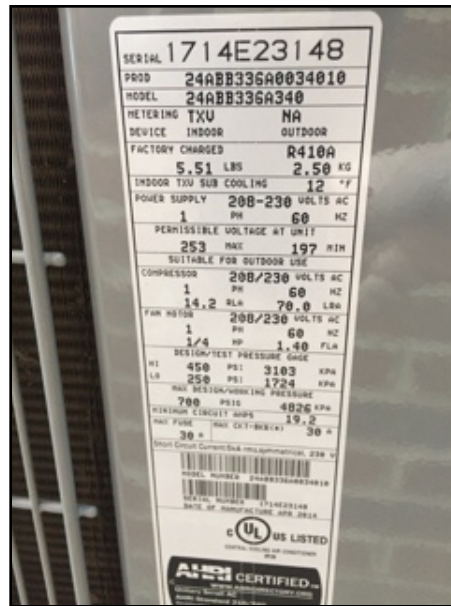
Figure 19-1

Comment 19:
AC unit and data plate for basement unit. Operates as expected.

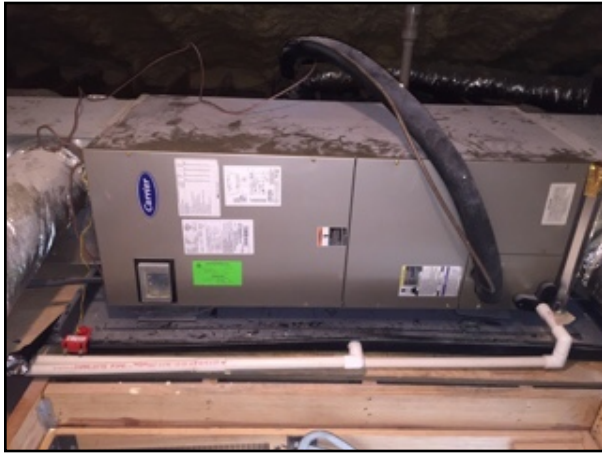
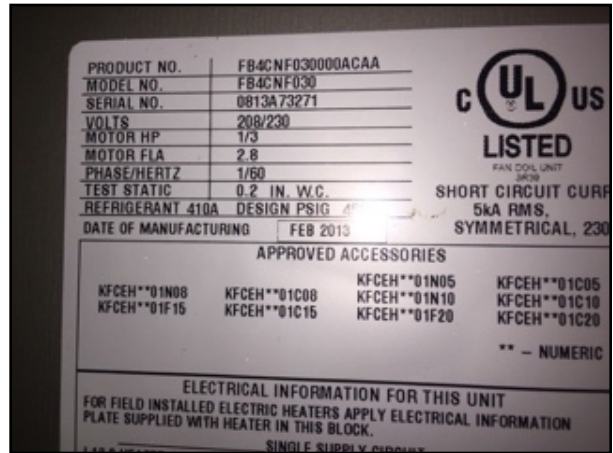
Figure 20-1

Heat pump and data plate. Operates as expected.

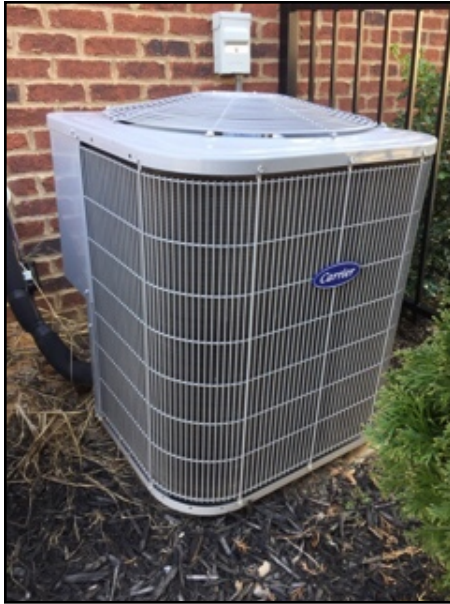
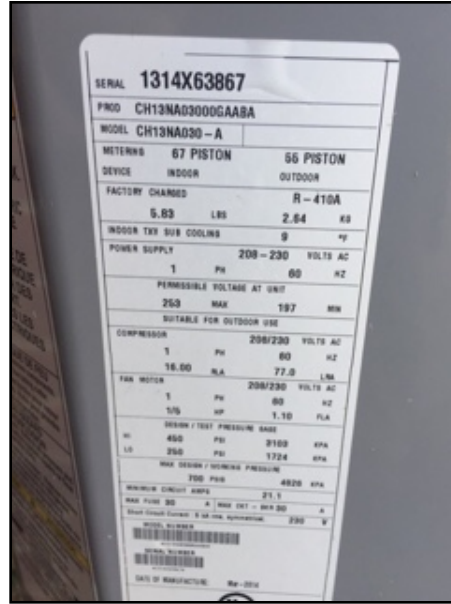
Figure 21-1

Heat pump and data plate for second floor. Operates as expected.

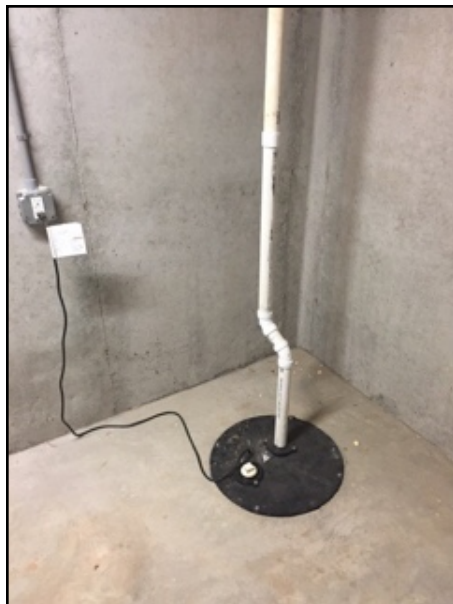
Figure 22-1

Comment 22:
Sealed sump pump is present. Unable to operate in order to inspect.

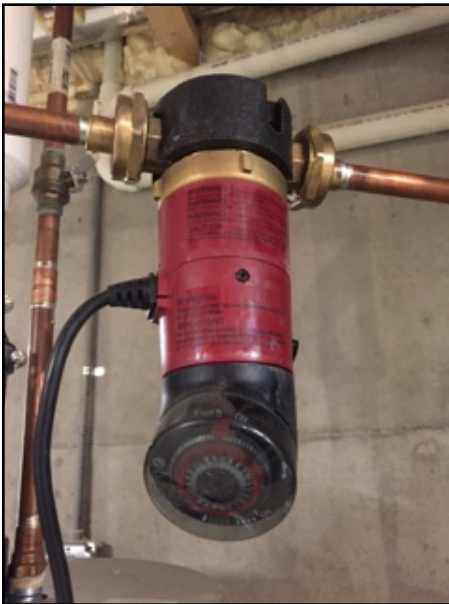
Figure 23-1

Comment 23:
Hot water circulation pump installed. Appears to operate as expected.

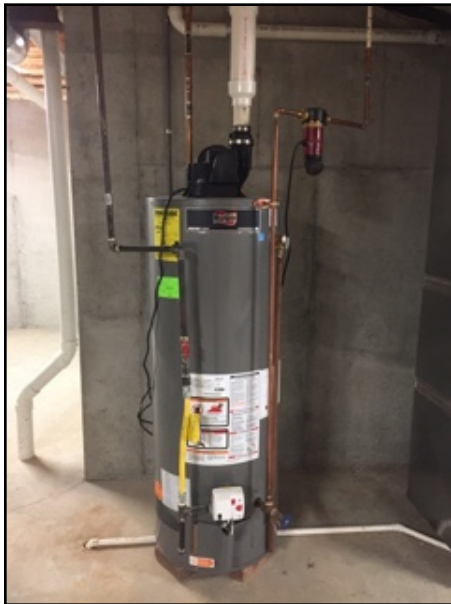
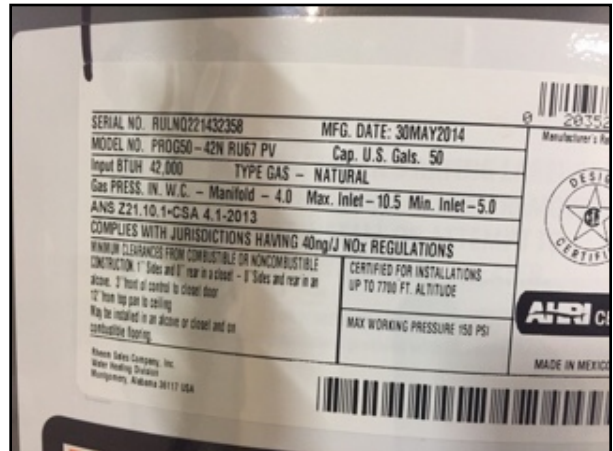
Figure 24-1

Water heater and data plate. Operates as expected.

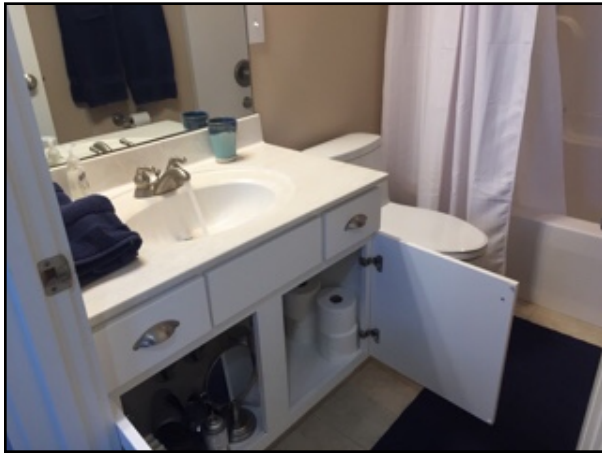
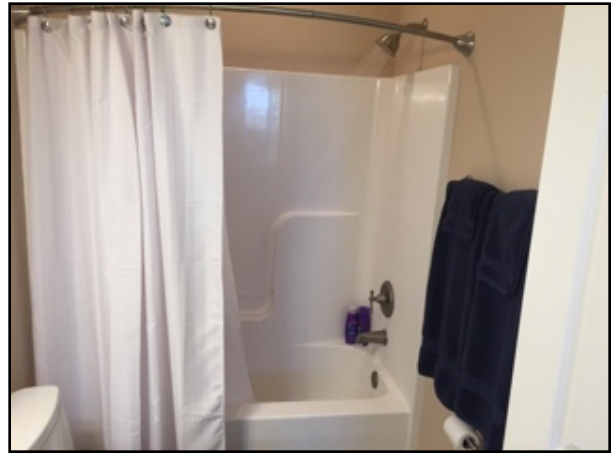
Figure 25-1

Comment 25:
Hall bath fixtures operate as expected. Ok.

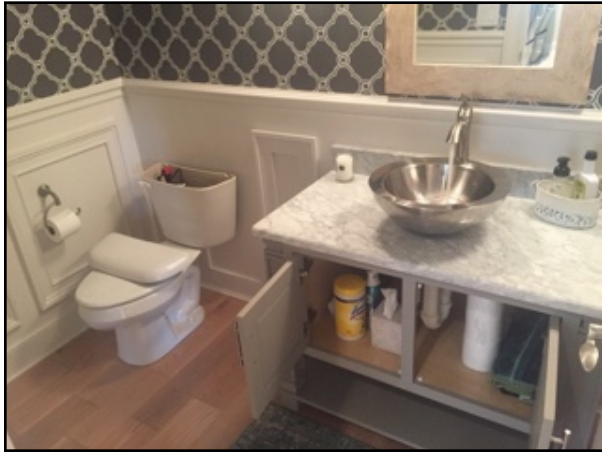
Figure 26-1

Half bath fixtures operate as expected. Ok.

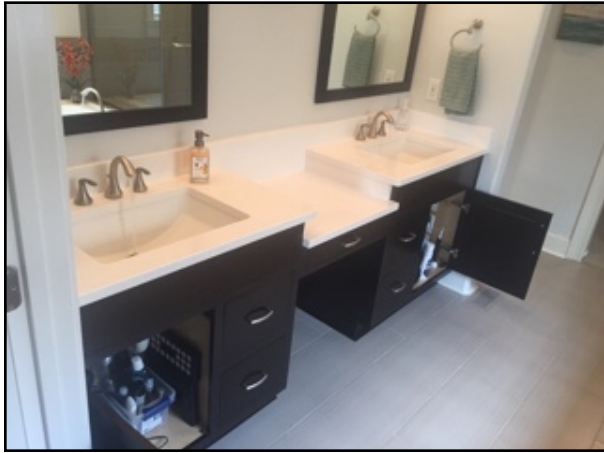
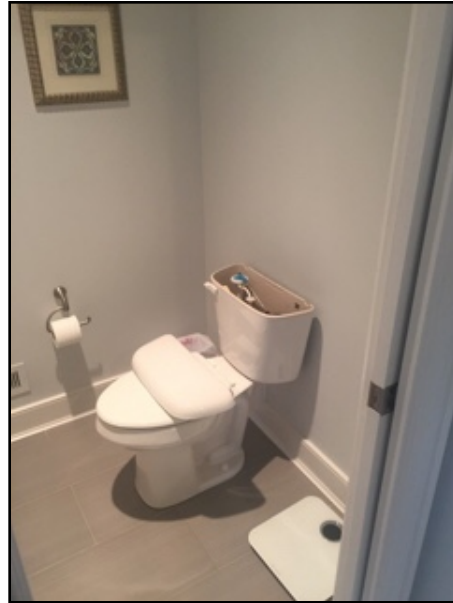
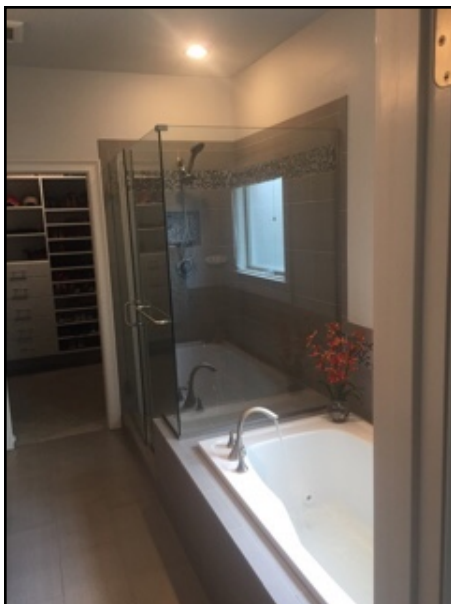
Figure 27-1

Master bath fixtures operate as expected. Ok.

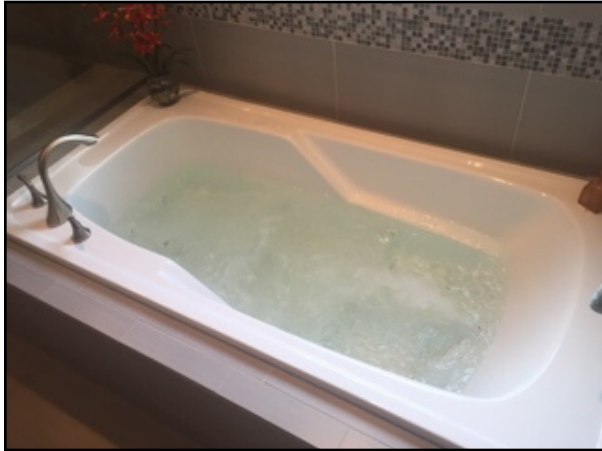
Figure 28-1

- i** Comment 28:
Whirlpool tub operates as expected. Fill and run with 2 cups of bleach for 15 minutes to clean and then refill with plain water and run to rinse.

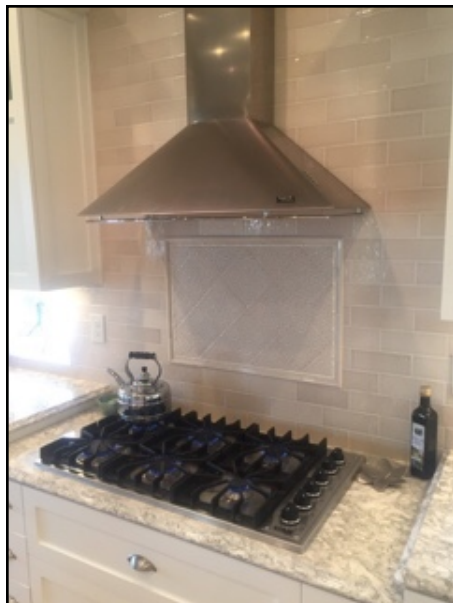
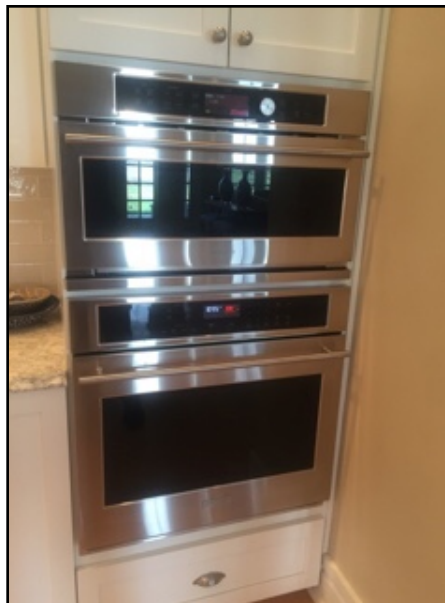
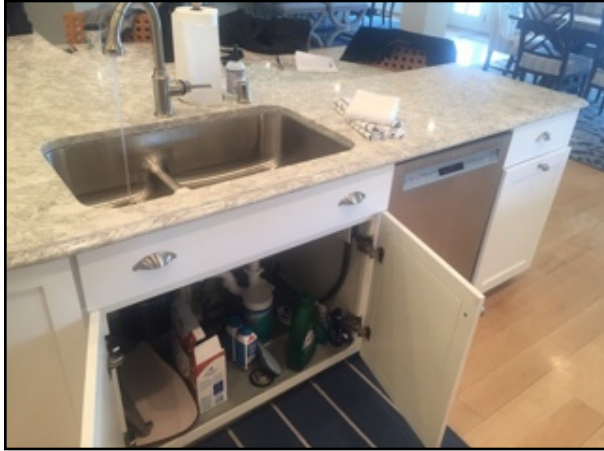
Figure 29-1

Appliances operate as expected except as otherwise noted. Ok.

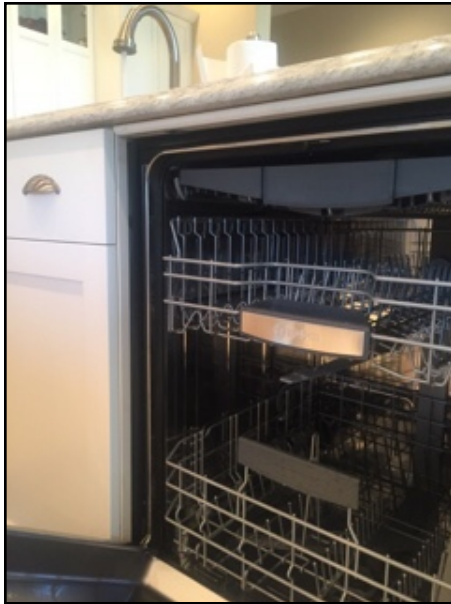
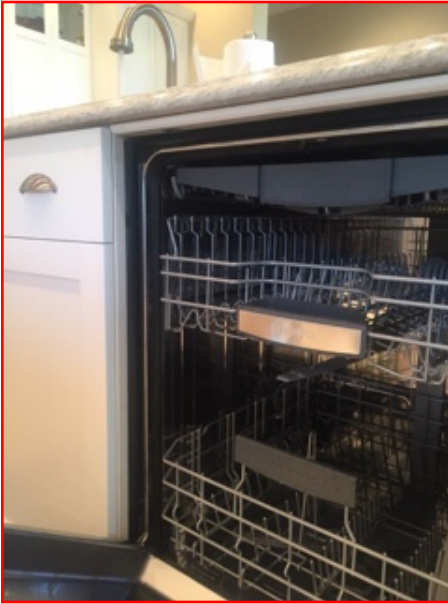
Figure 30-1

Dishwasher is not secured to counter. Have fully installed, leveled and operation verified before closing.

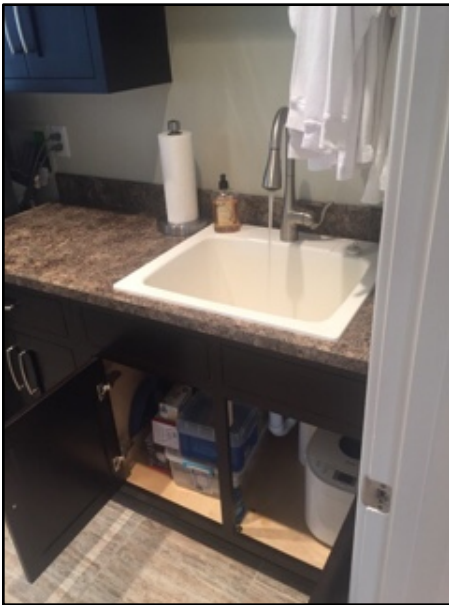
Figure 31-1

Comment 31:
Laundry sink operates as expected.

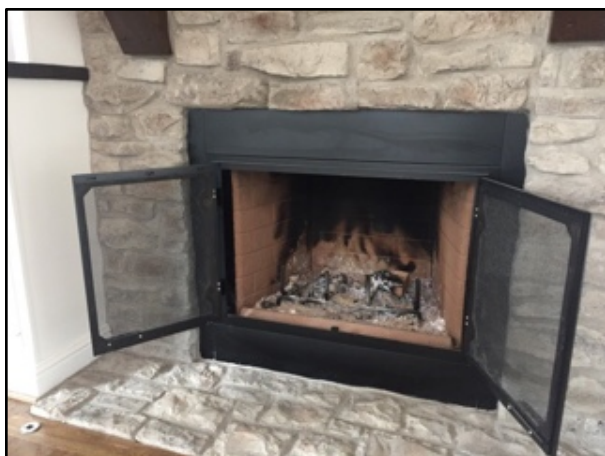
Figure 32-1

Wood burning fireplace is in acceptable condition. Ok. Have cleaned yearly by chimney sweep if used.
